HISTORY HOUSE

113 Macquarie Street
Sydney, NSW

Conservation Management Plan

Revision of 2001 CMP

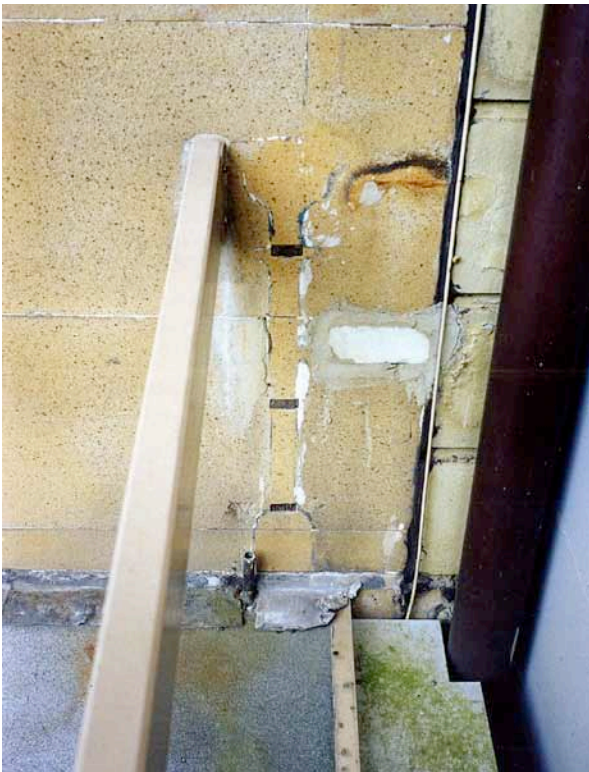
FIGURE 2.29: First floor verandah, evidence of north panel and louvered screen

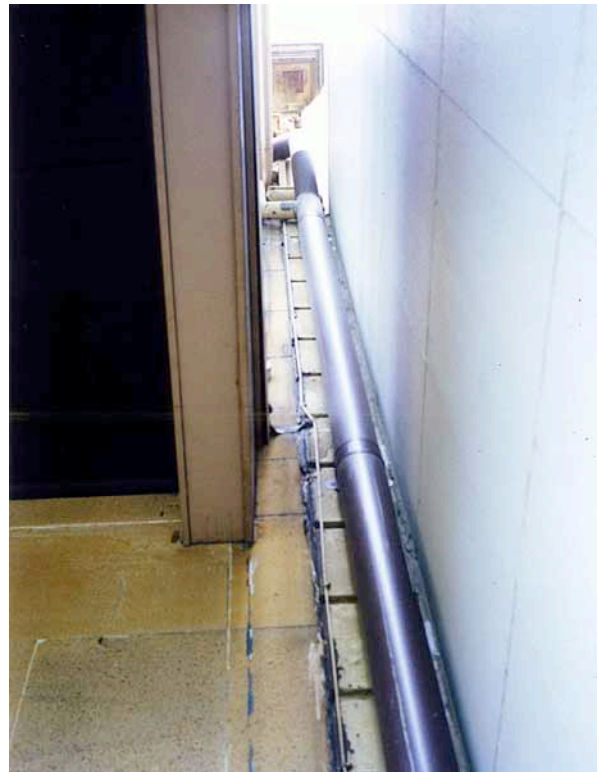
FIGURE 2.30: Surviving wall section behind downpipe, from No. 131 Macquarie Street to the north

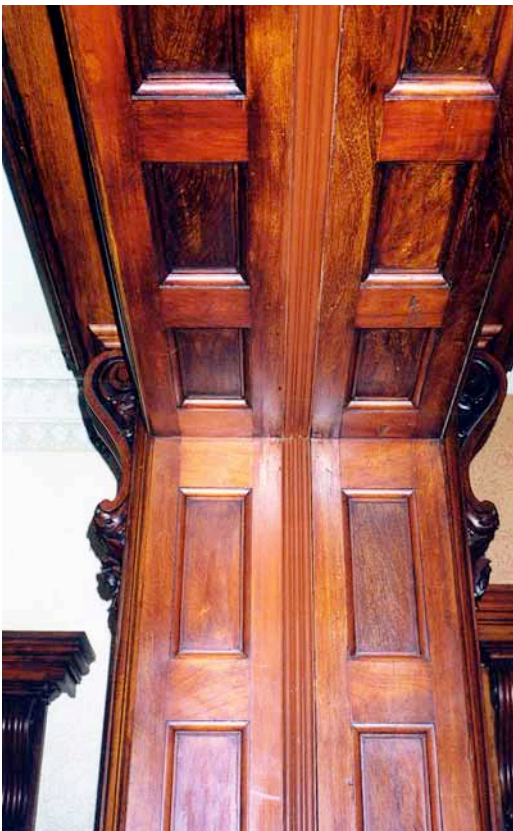
FIGURE 2.44: Detail of doorcase dividing the parlour from the dining room, showing the recent filing of the sliding door gap.

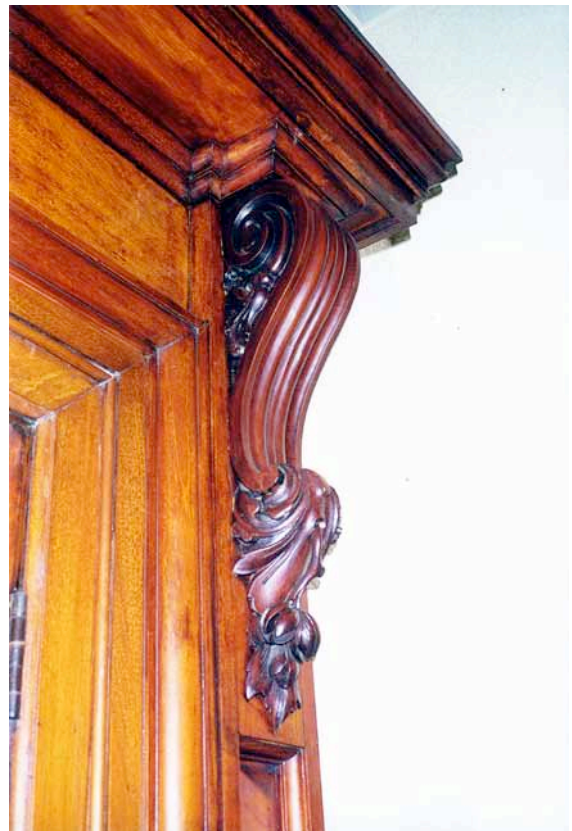
FIGURE 2.45: Detail of corbel to doorcase
